# Identification of Landslide Zones At Mettupalayam To Udagamandalam Using GIS & Remote Sensing

**Abstract-** Despite advancements in recognition, prediction, and preventive measures, landslides continue to cause significant social, economic, and environmental damage in the Nilgiris district, Tamil Nadu. This persistent issue stems from the complexity of slope failure mechanisms and our incomplete understanding of the underlying factors.

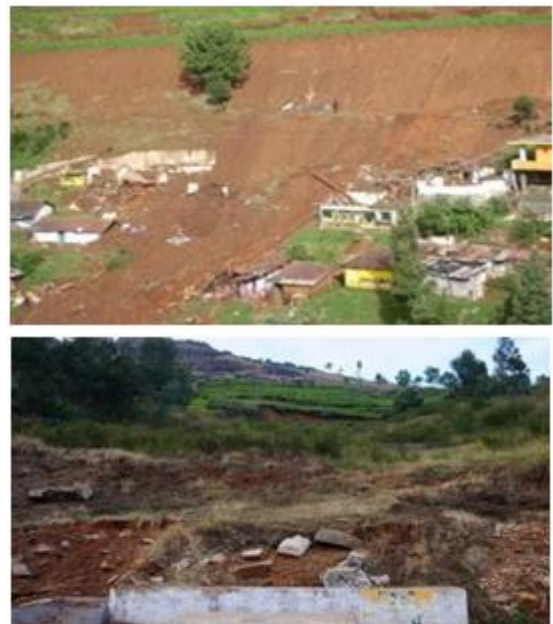
Fig 5.3.1 During landslide

One of the primary causes of landslides in this region is the **blocking of natural water pathways along the hills**. Experts emphasize the urgent need to address **encroachments**, as they contribute significantly to slope instability. Unfortunately, whenever landslides occur near **unplanned settlements** or **encroached colonies**, the underlying causes are often overlooked. Instead of implementing **long-term solutions**, authorities resort to **temporary fixes**, such as covering the affected areas with sandbags. Due to the **lack of permanent mitigation measures**, these locations remain vulnerable to **recurrent landslides**.

This slope, though smaller, is steeper due to land cutting and encroachments. It is at high risk of landslides throughout the year due to both external loads and rainfall. The abrupt change in terrain, combined with its location at a major bus stop, poses significant hazards to property and accessibility.

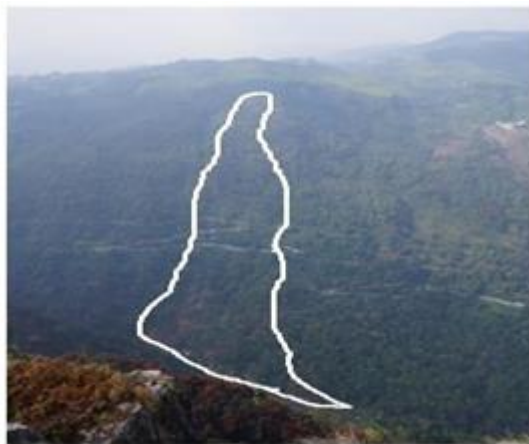
Fig 5.4.1 During Landslide

The **coordinates** of the study area are **Latitude: 11.403183, Longitude: 76.72422**. The region's **topography and geology** play a crucial role in landslide occurrences. The **Nilgiris Mountains** consist of numerous **spurs and branches extending in multiple directions**, with **narrow crests separated by deep gorges and valleys**. These valleys contain **high-velocity streams**, which rapidly transport runoff from the surrounding hills.

This landslide site is along State Highway SH-15 (Ooty-Kotagiri Road) and is one of the largest landslides recorded in the Nilgiri district. The primary causes of failure include high pore pressure, crown cutting, and slope excavation for road construction. The lack of proper retaining structures has further aggravated instability.
